Field Study of the Effect of Ice on Sediment Transport and Shoreline Erosion - St. Marys
River, St. Clair River, Detroit River, Michigan: Volume IV

FIELD STUDY OF THE EFFECT OF ICE
ON
SEDIMENT TRANSPORT AND SHORELINE EROSION
ST. MARYS RIVER, ST. CLAIR RIVER, DETROIT RIVER
MICHIGAN

SUBMITTED BY: GEORGE R. ALGER, PHD
WATER RESOURCES CONSULTANT

SEPTEMBER 1979

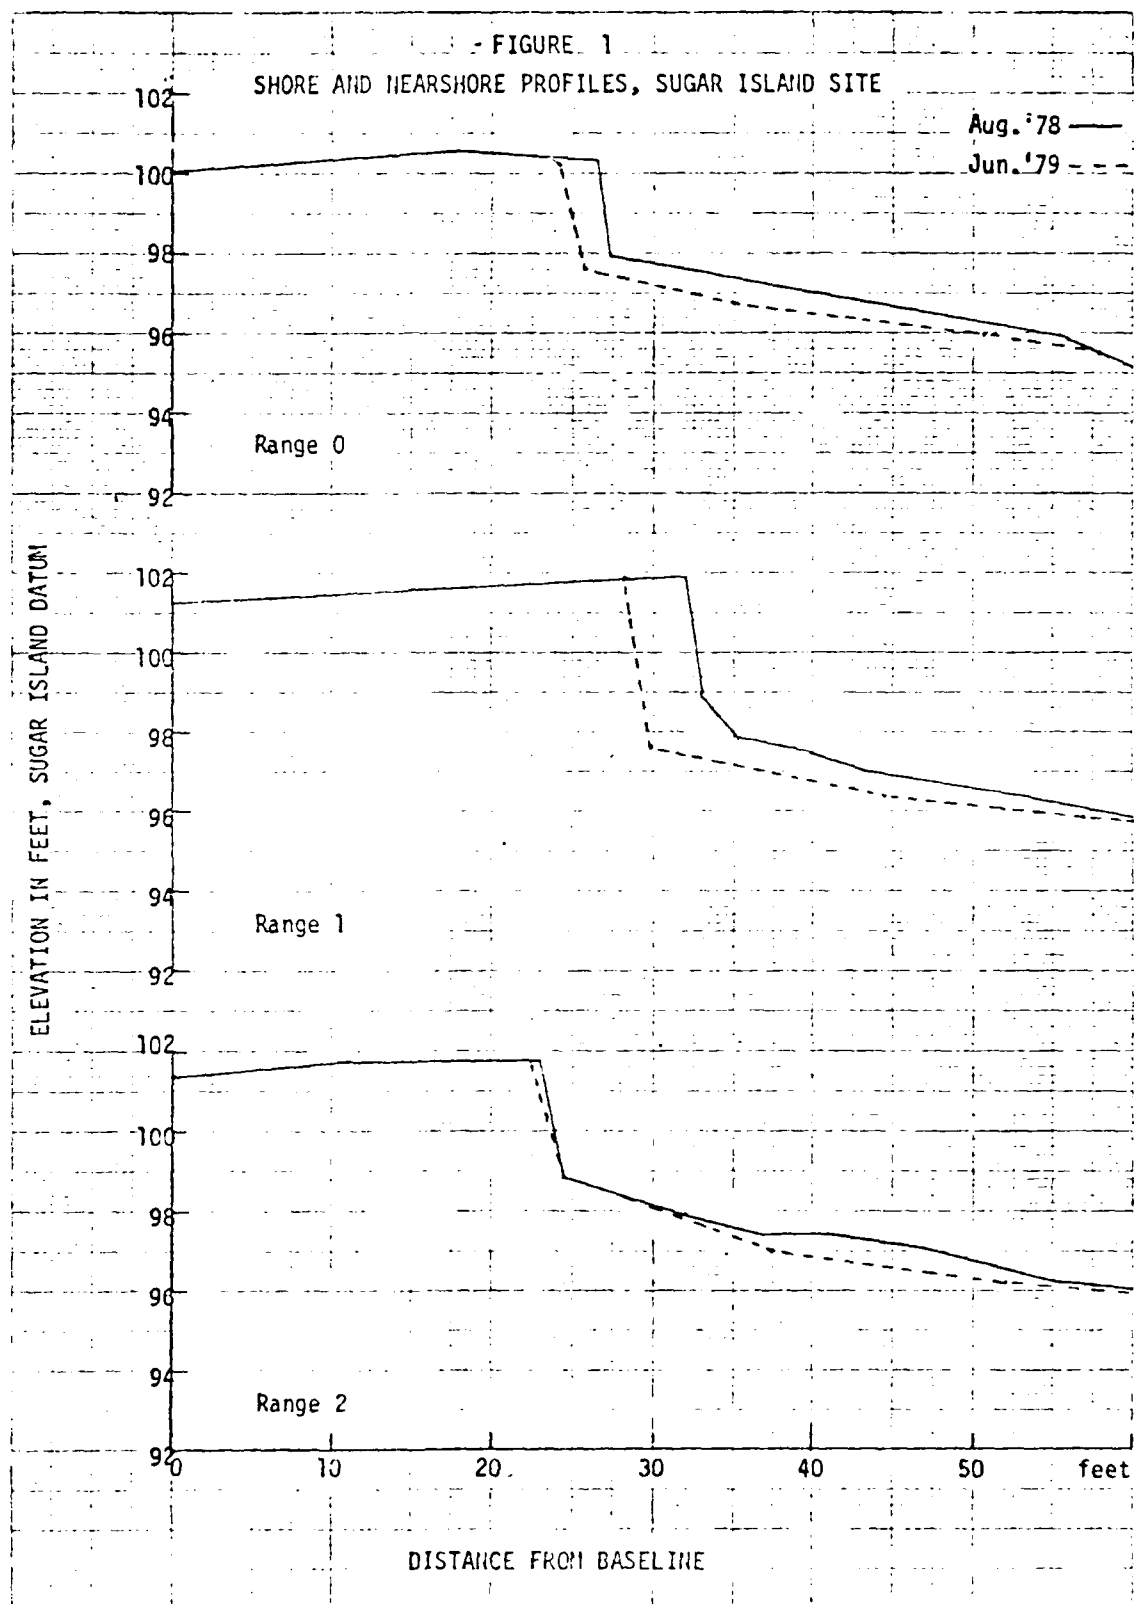
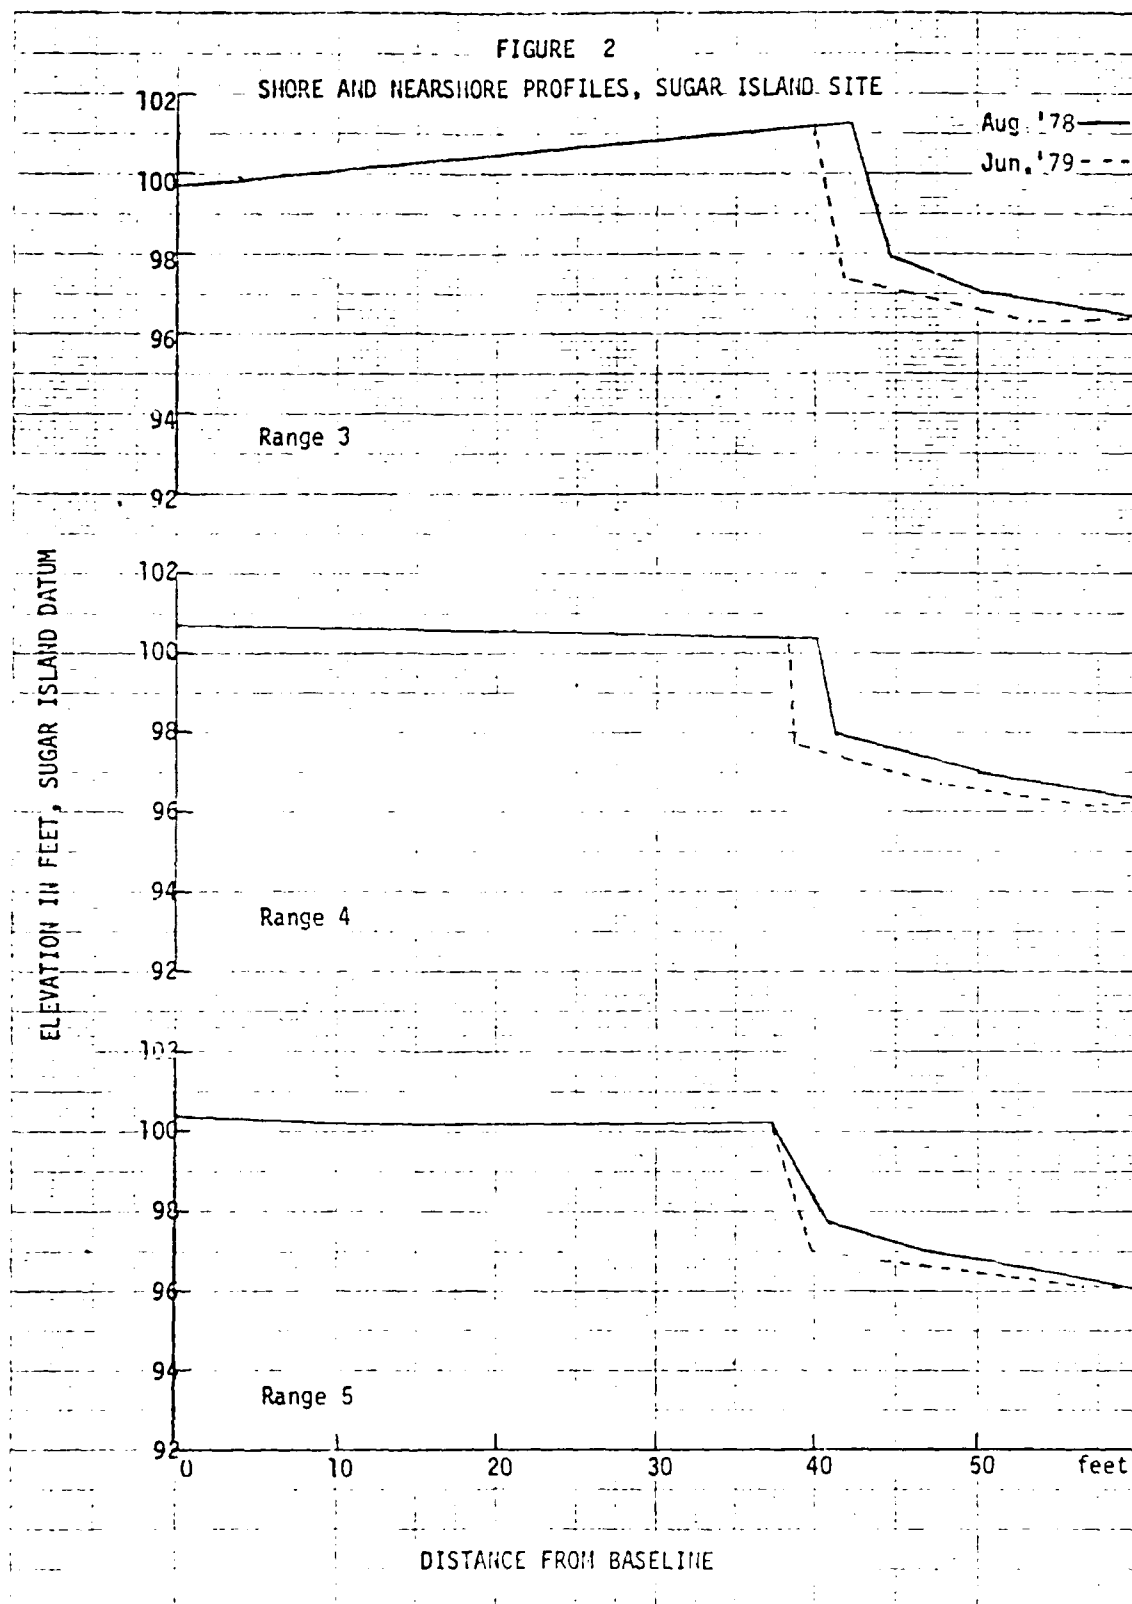
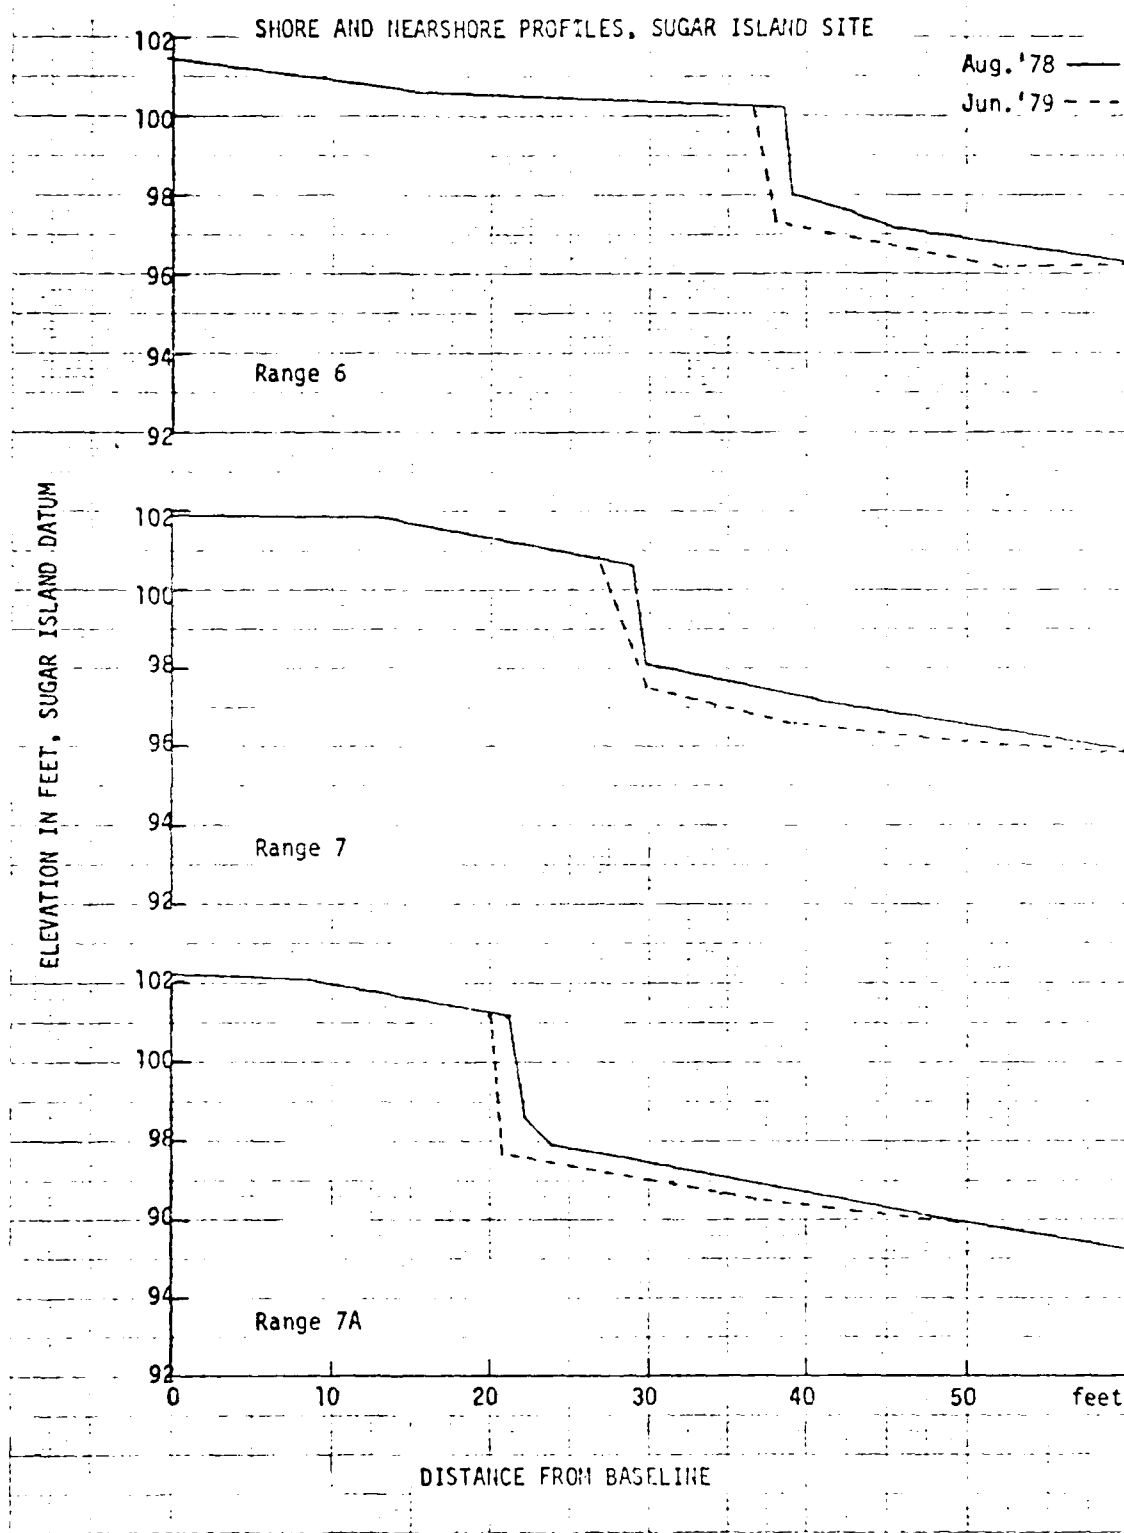
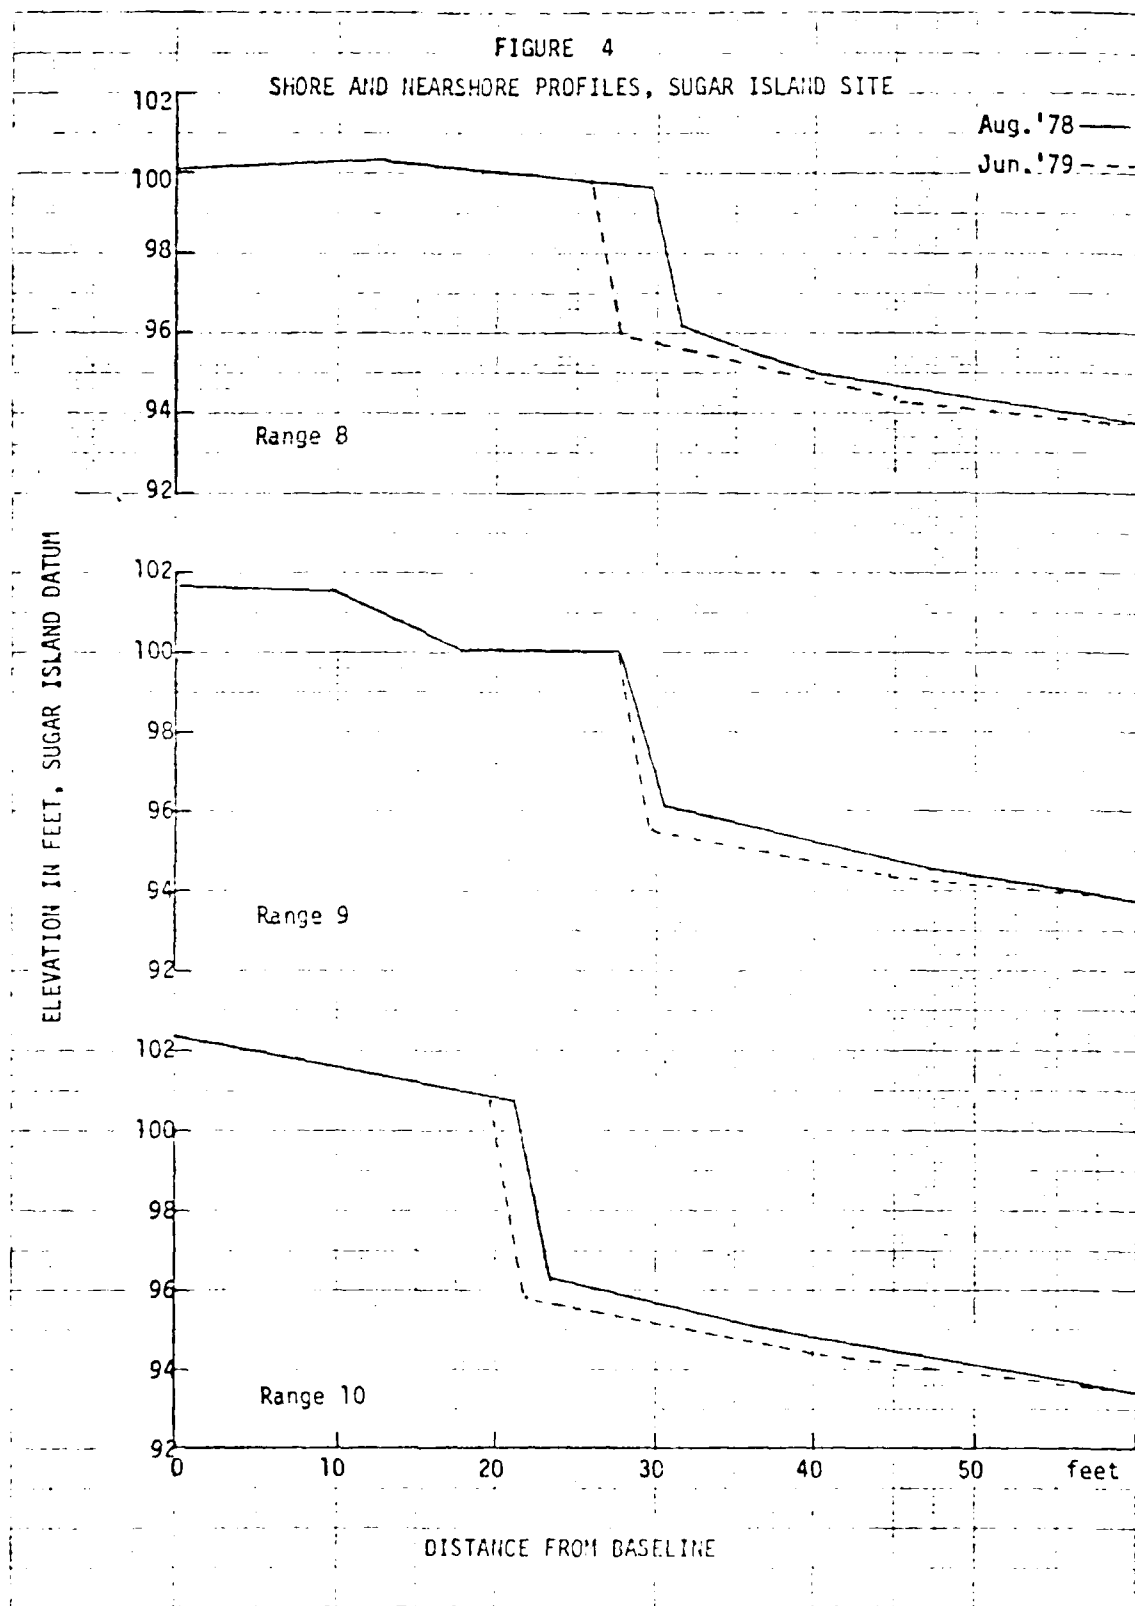
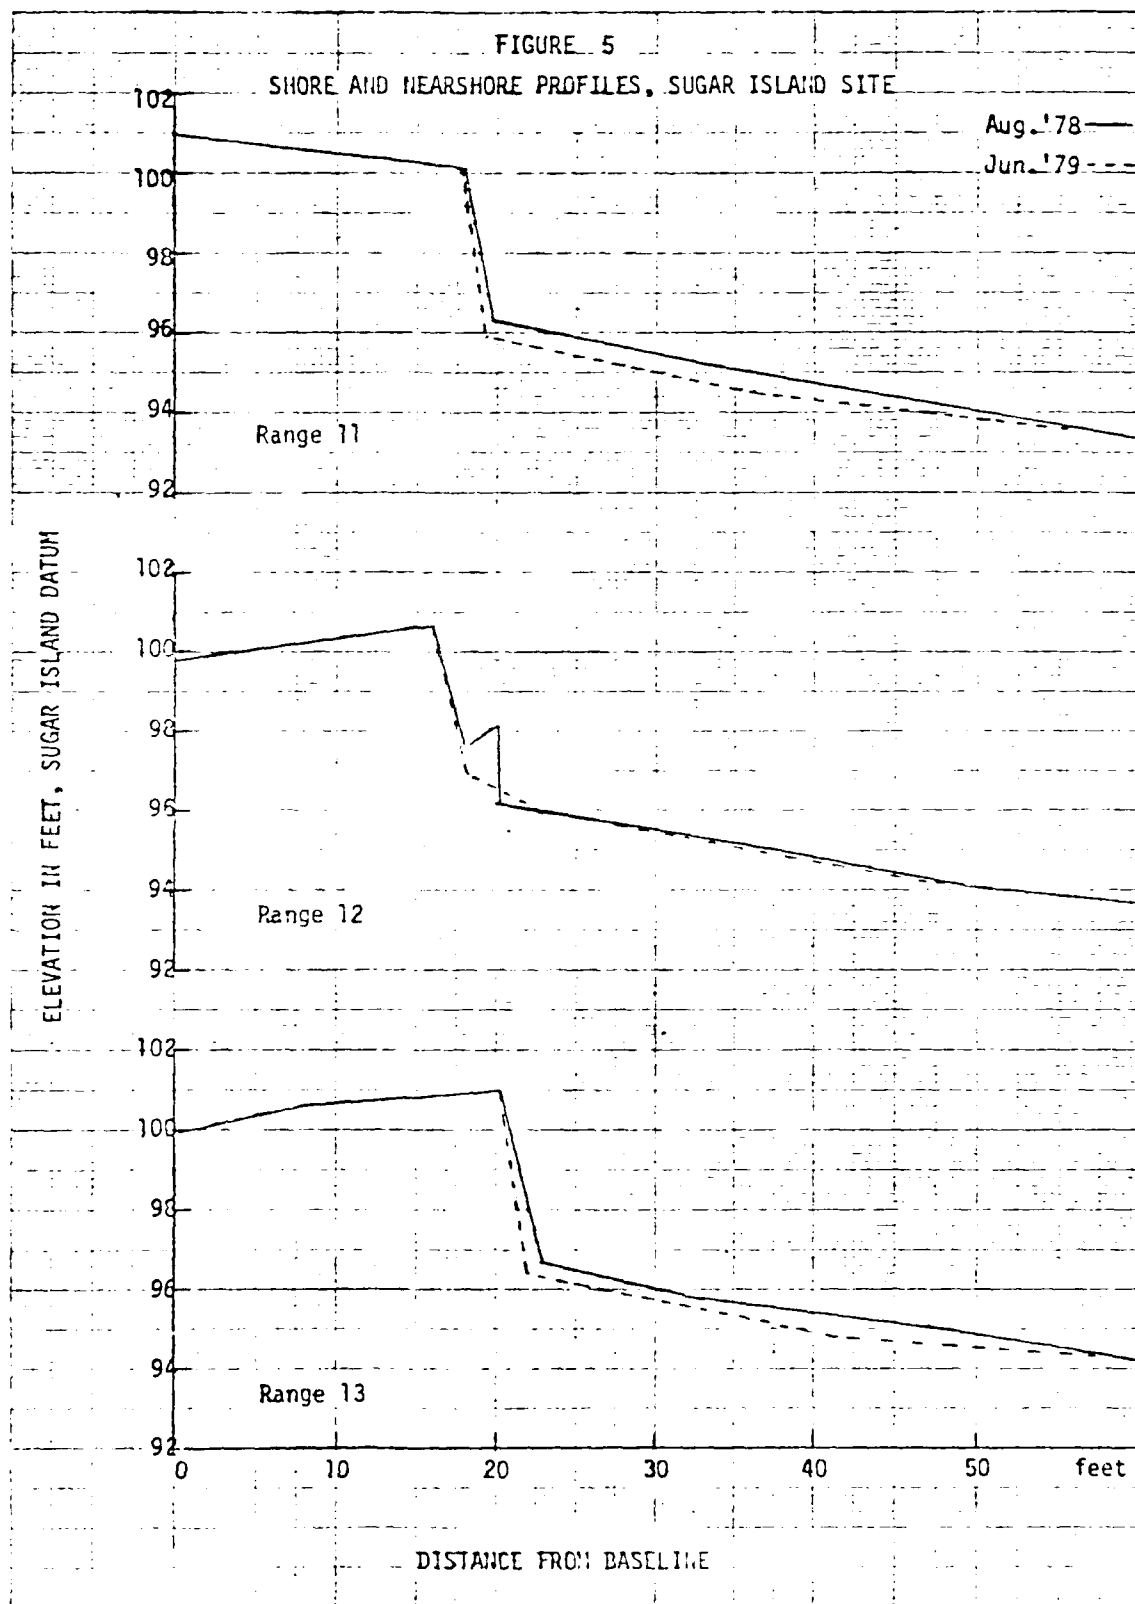
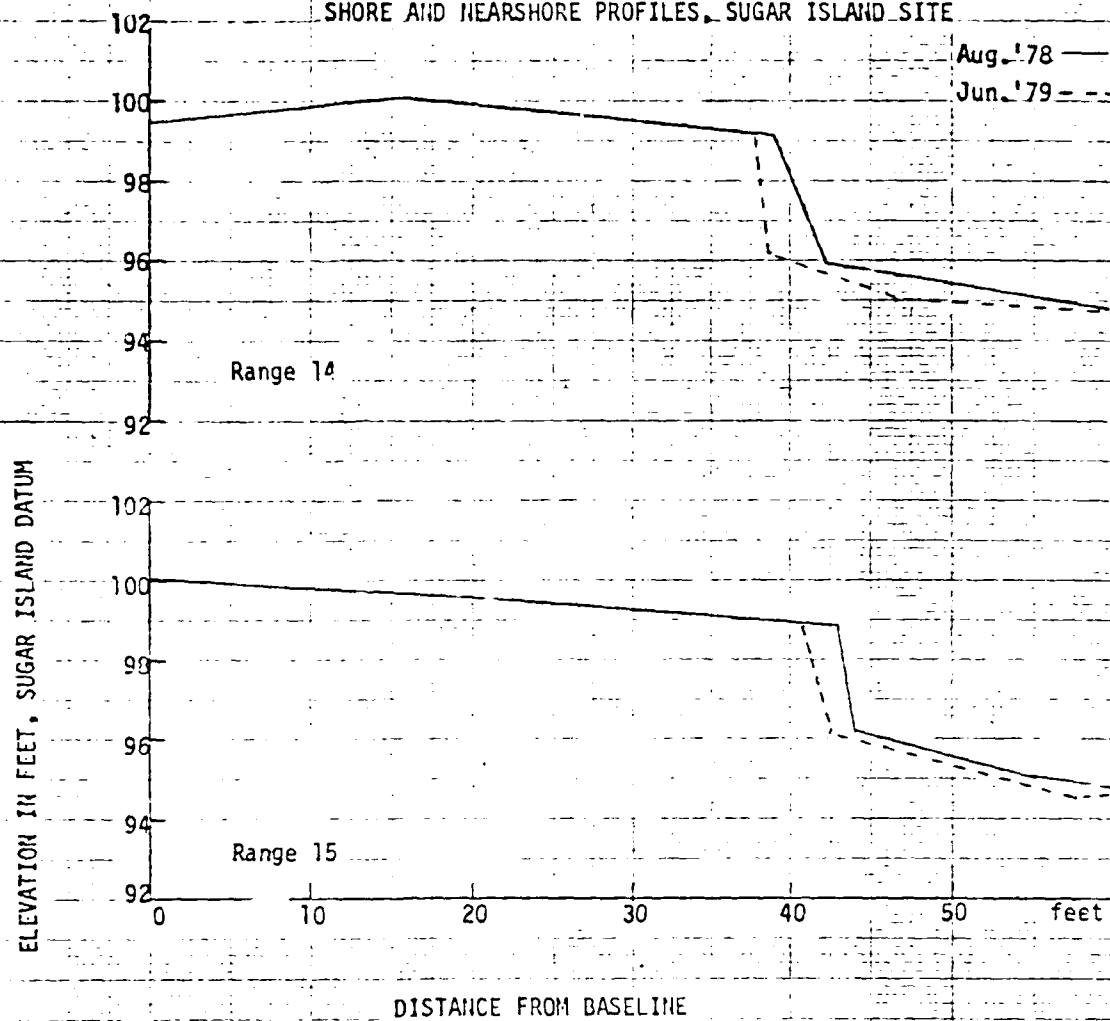
FIGURE 6
SHORE AND NEARSHORE PROFILES, SUGAR ISLAND SITE

The shore and nearshore topography and bathymetry were determined in June of 1979 using a level and level rod. Similar measurements made at this site during previous years (Volumes 1, 2 and 3) beginning in August of 1976 have shown little or no change during the intervening period. However, the measurements made in June of 1979 under this contract show bluff recession along several of the ranges. This information is illustrated on Figures 1 through 6.

The river elevation (using the Sugar Island Site datum) was 98.44 ft., which is higher than any previous measurements done under this contract. As can be seen from the profiles this river elevation has submerged the lower part of the scarp face and consequently any wave action is transposed directly to the scarp face and would tend to localize such erosional forces there. As has been noted in previous reports the wave action generated by the passage of the many pleasure boats which utilize the river system is likely more detrimental than the waves generated by commercial vessels moving at regulated speed.

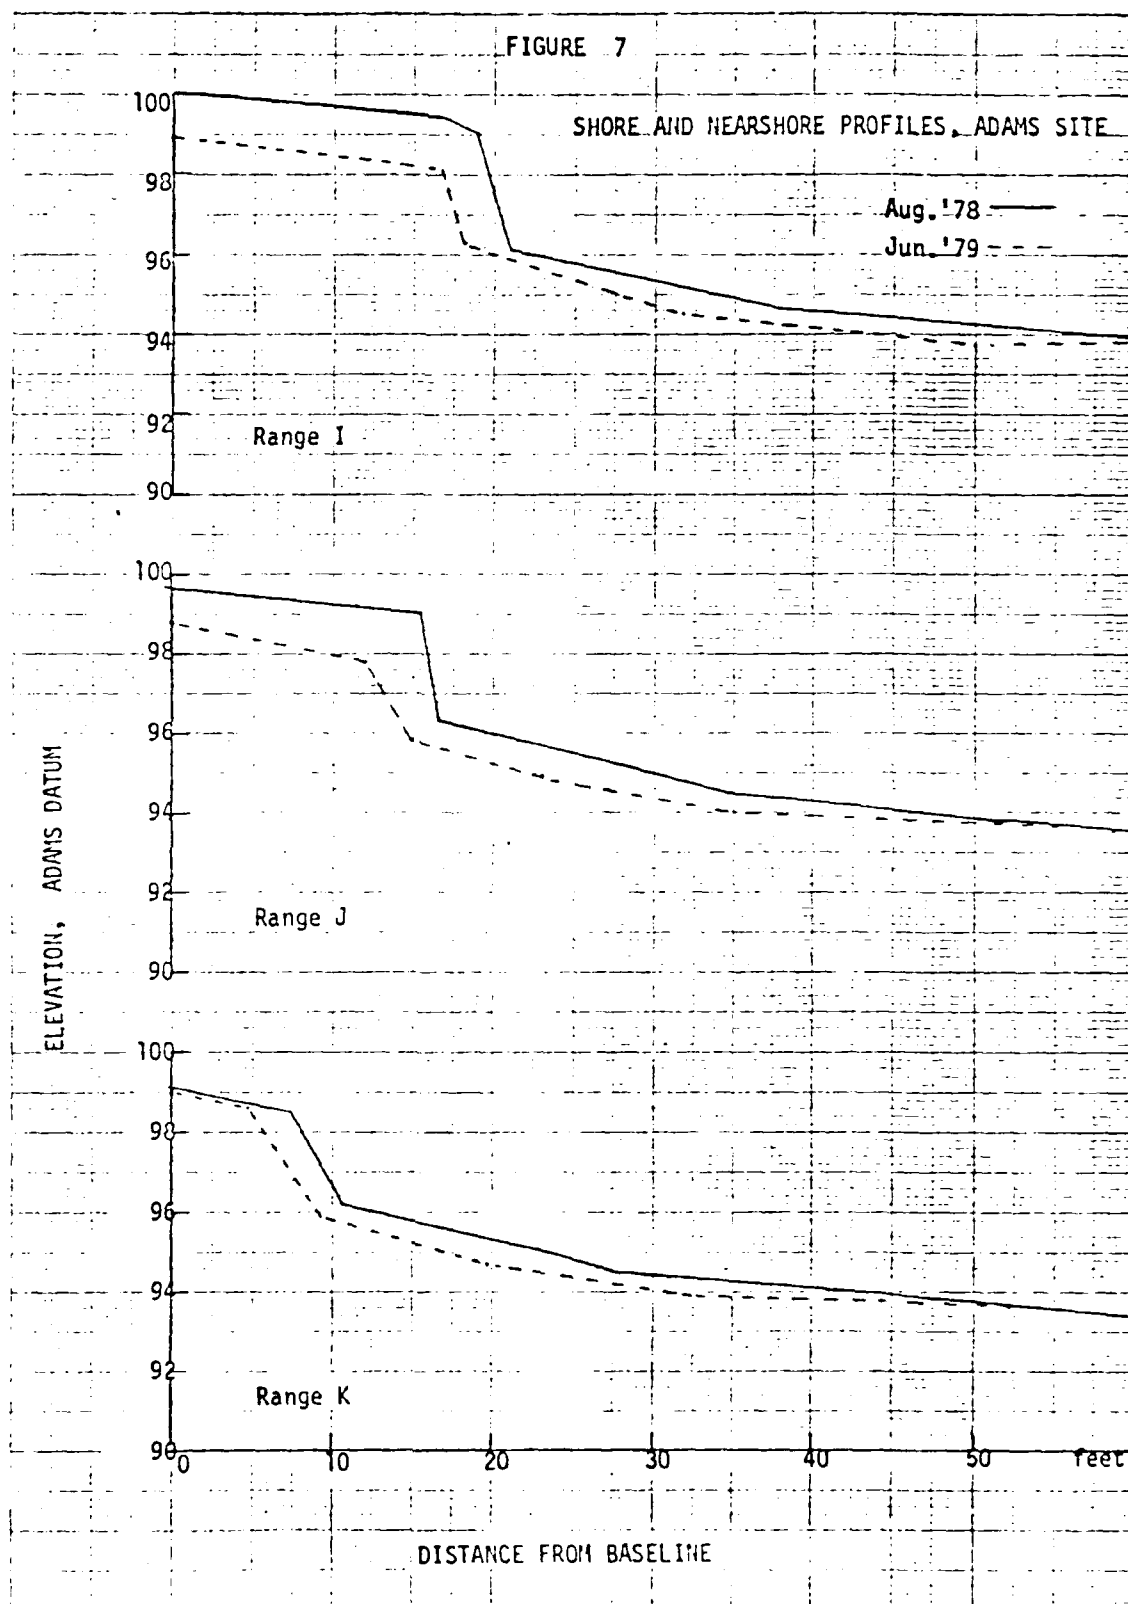
The shore and nearshore topography and bathymetry were determined in June 1979 using a level and level rod. Similar measurements made at this site during previous years (Volumes 1, 2 and 3) beginning in 1976 have shown little or no change during the intervening period. The results of the measurements made under this contract in June of 1979 again show no appreciable change except at Ranges I, J and K. A new home has been constructed in the area covered by these three ranges and the area between the home and rivers edge has been scraped in preparation for establishment of a new front lawn to the shore. This, in effect, has lowered the pre-construction shore elevation to some extent. This information is contained in Figure 7.

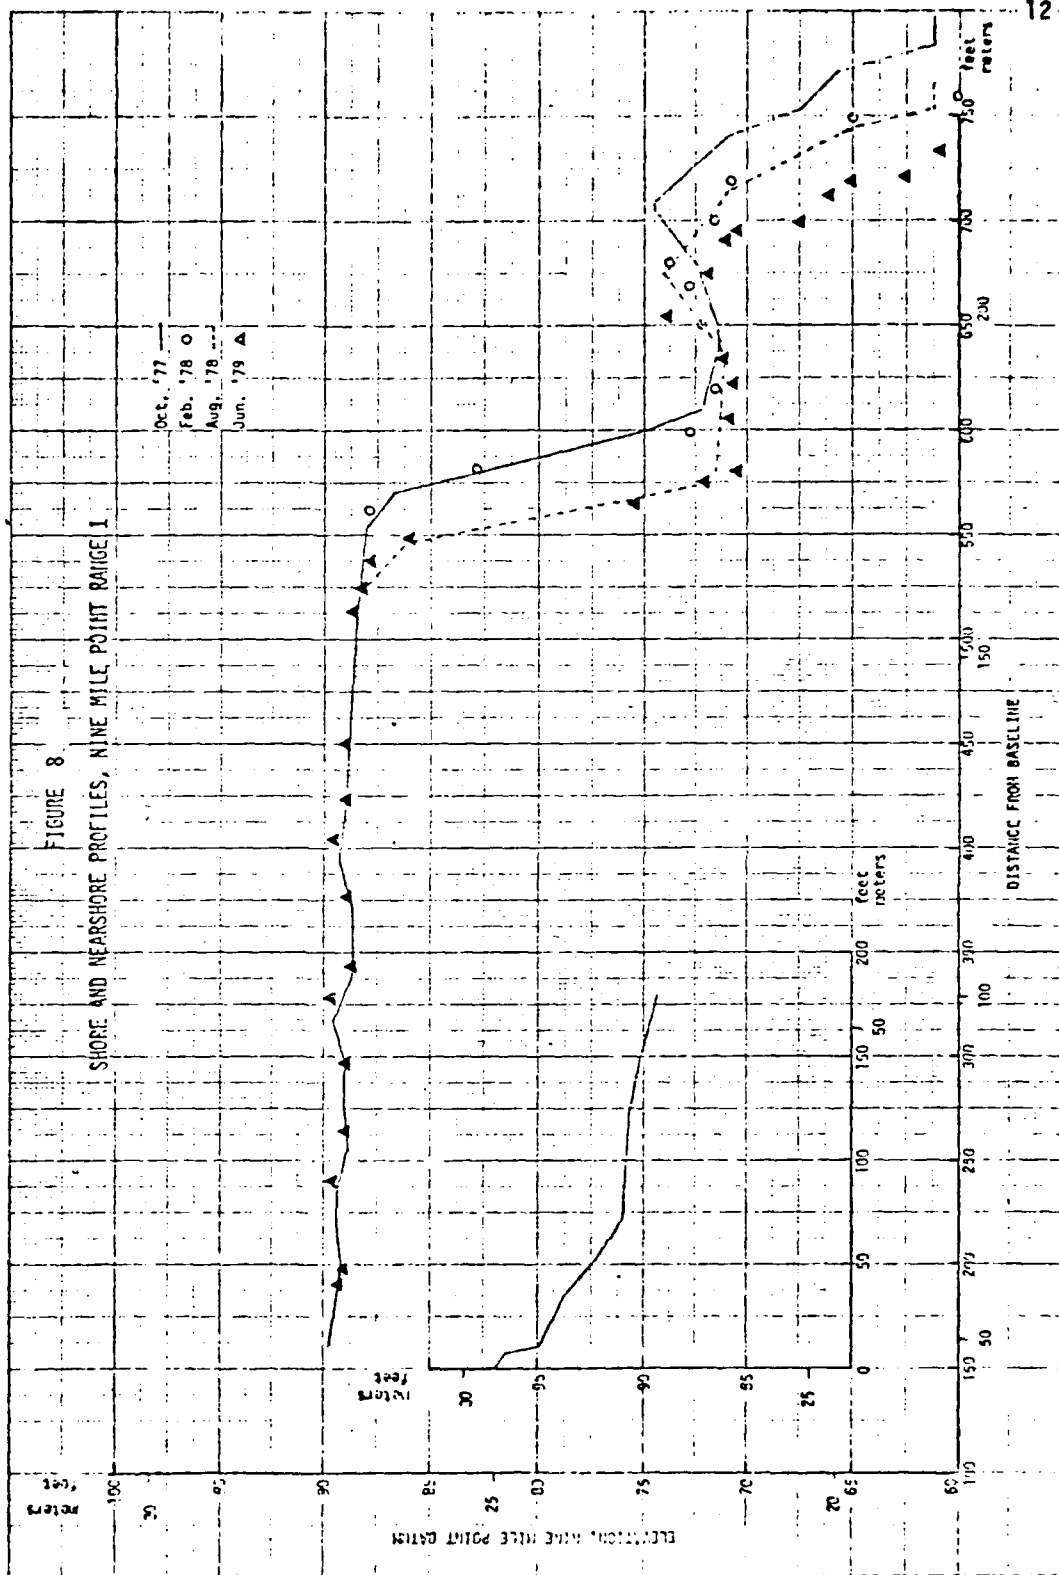
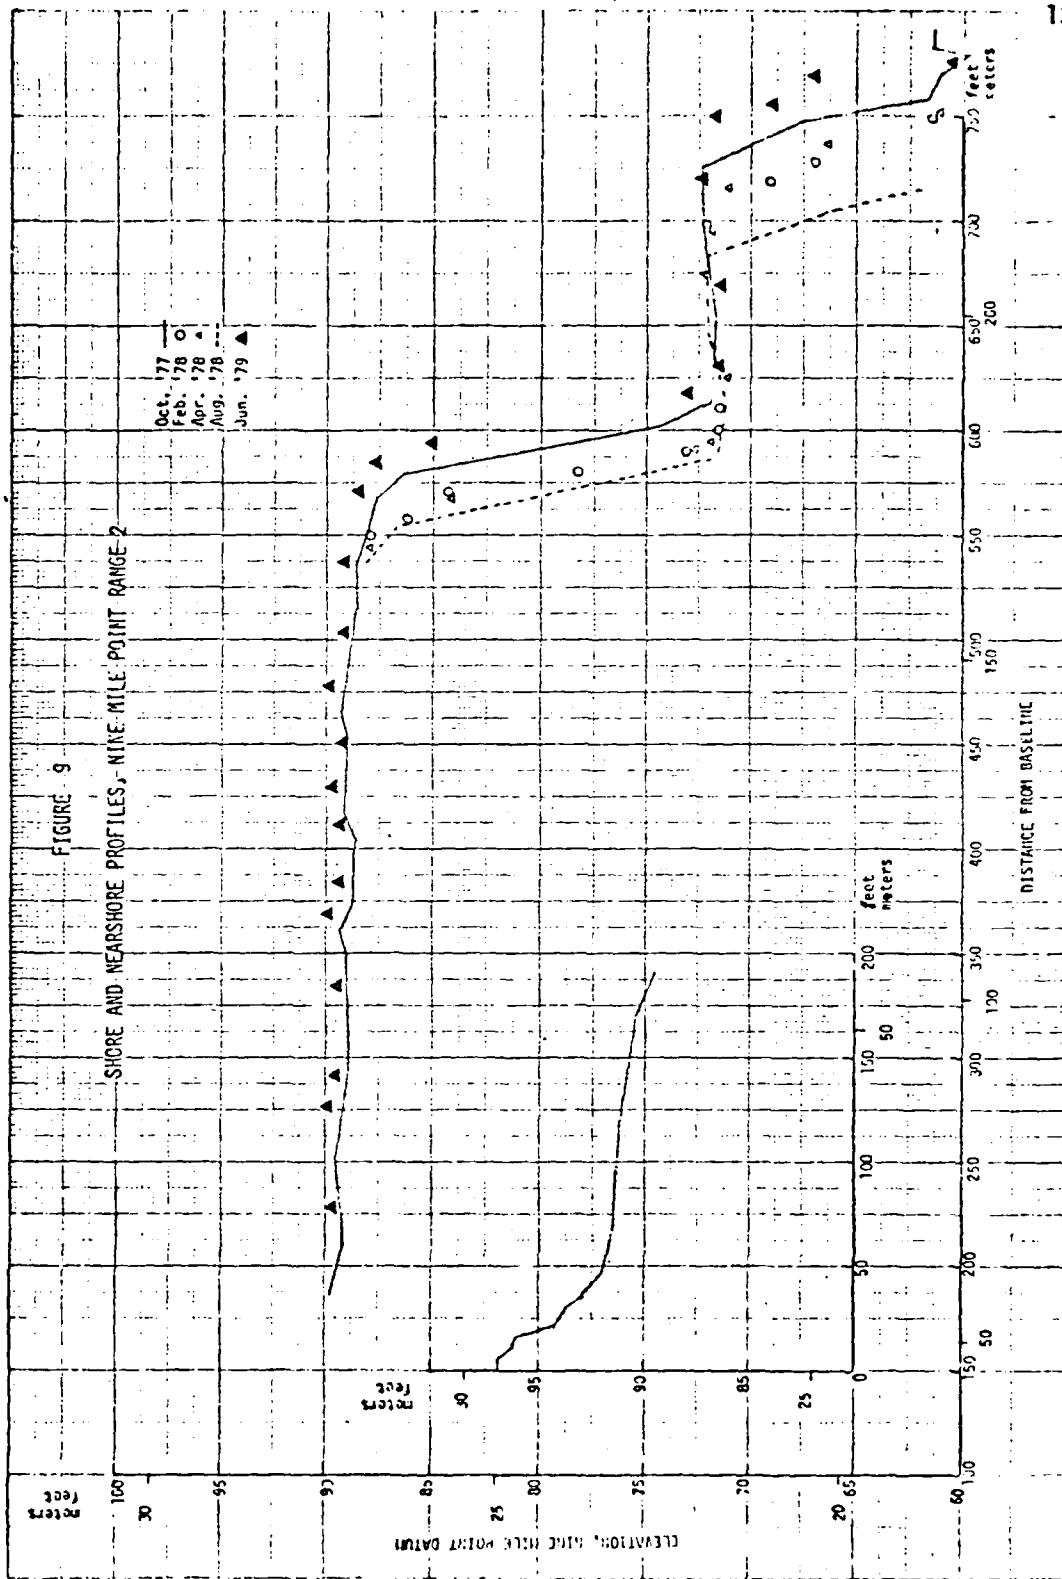
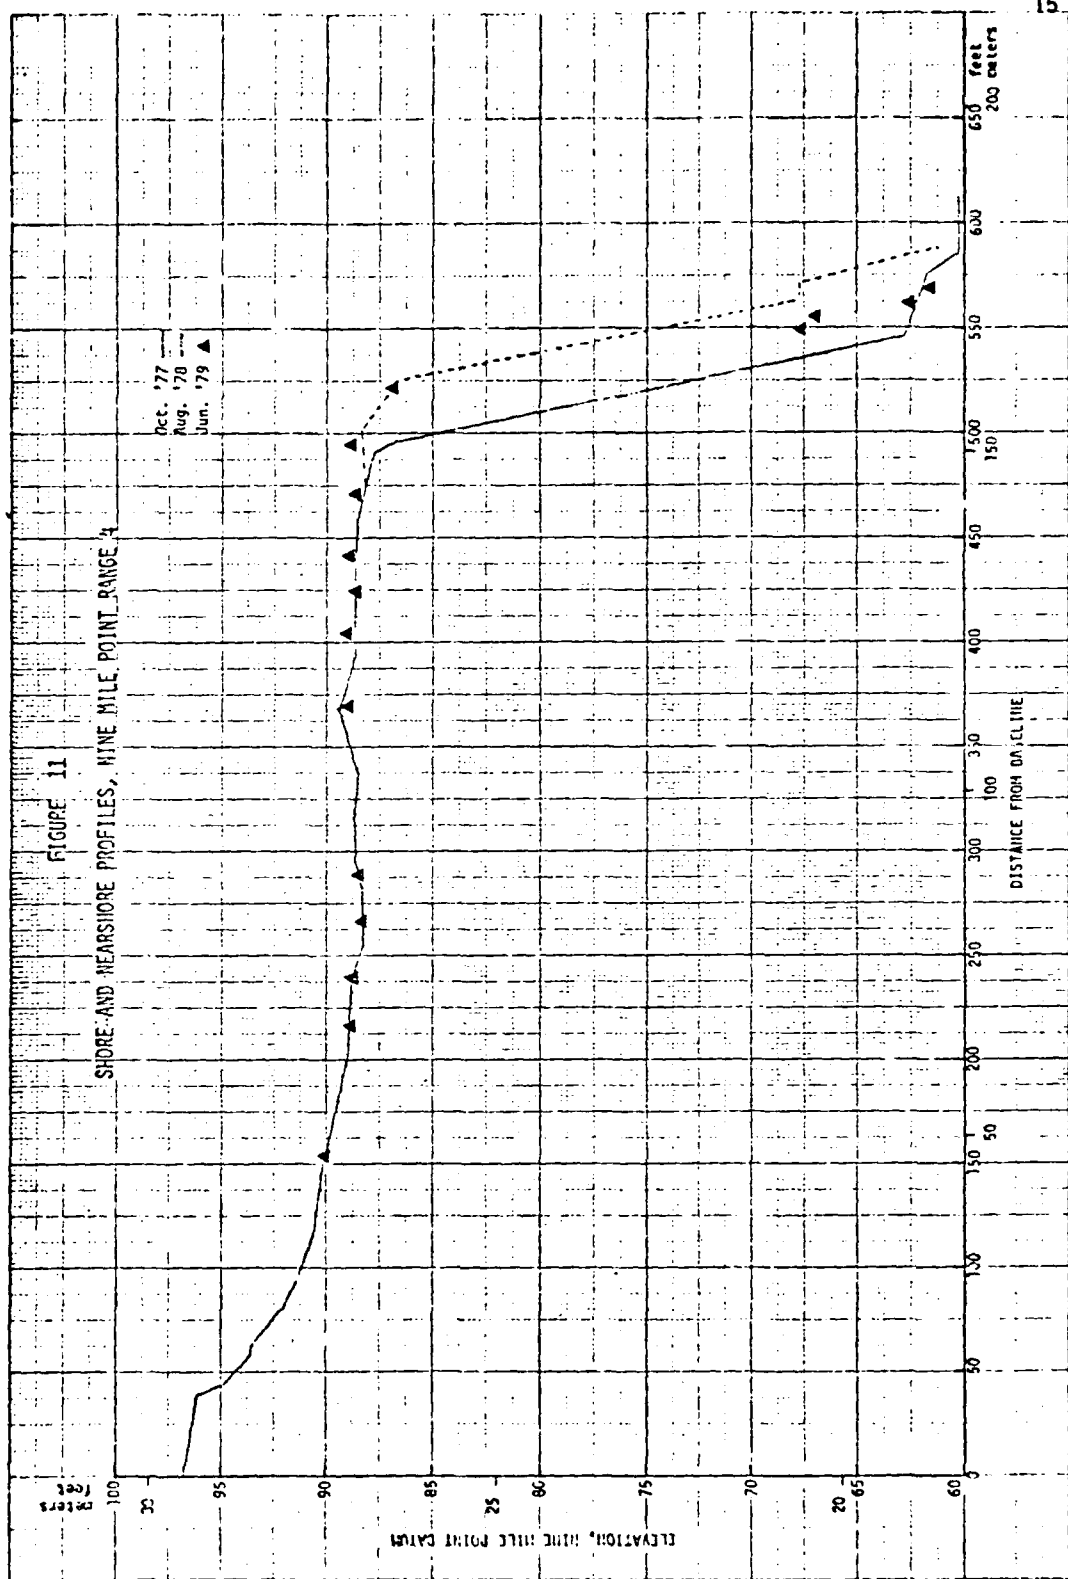
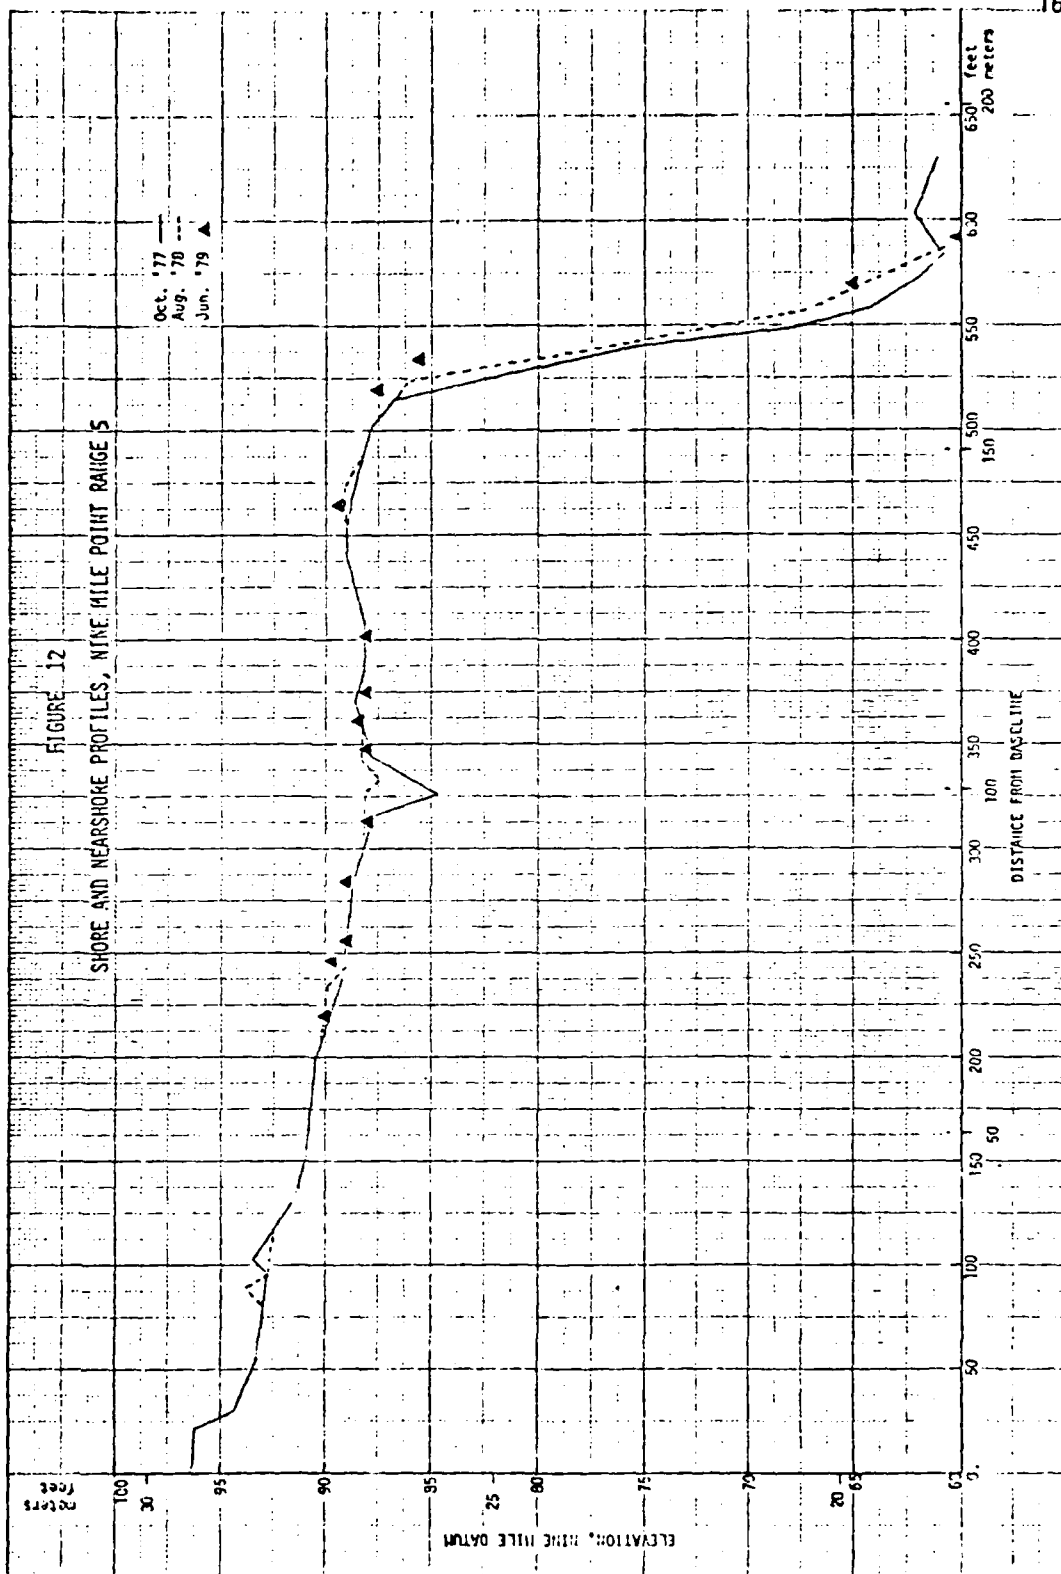
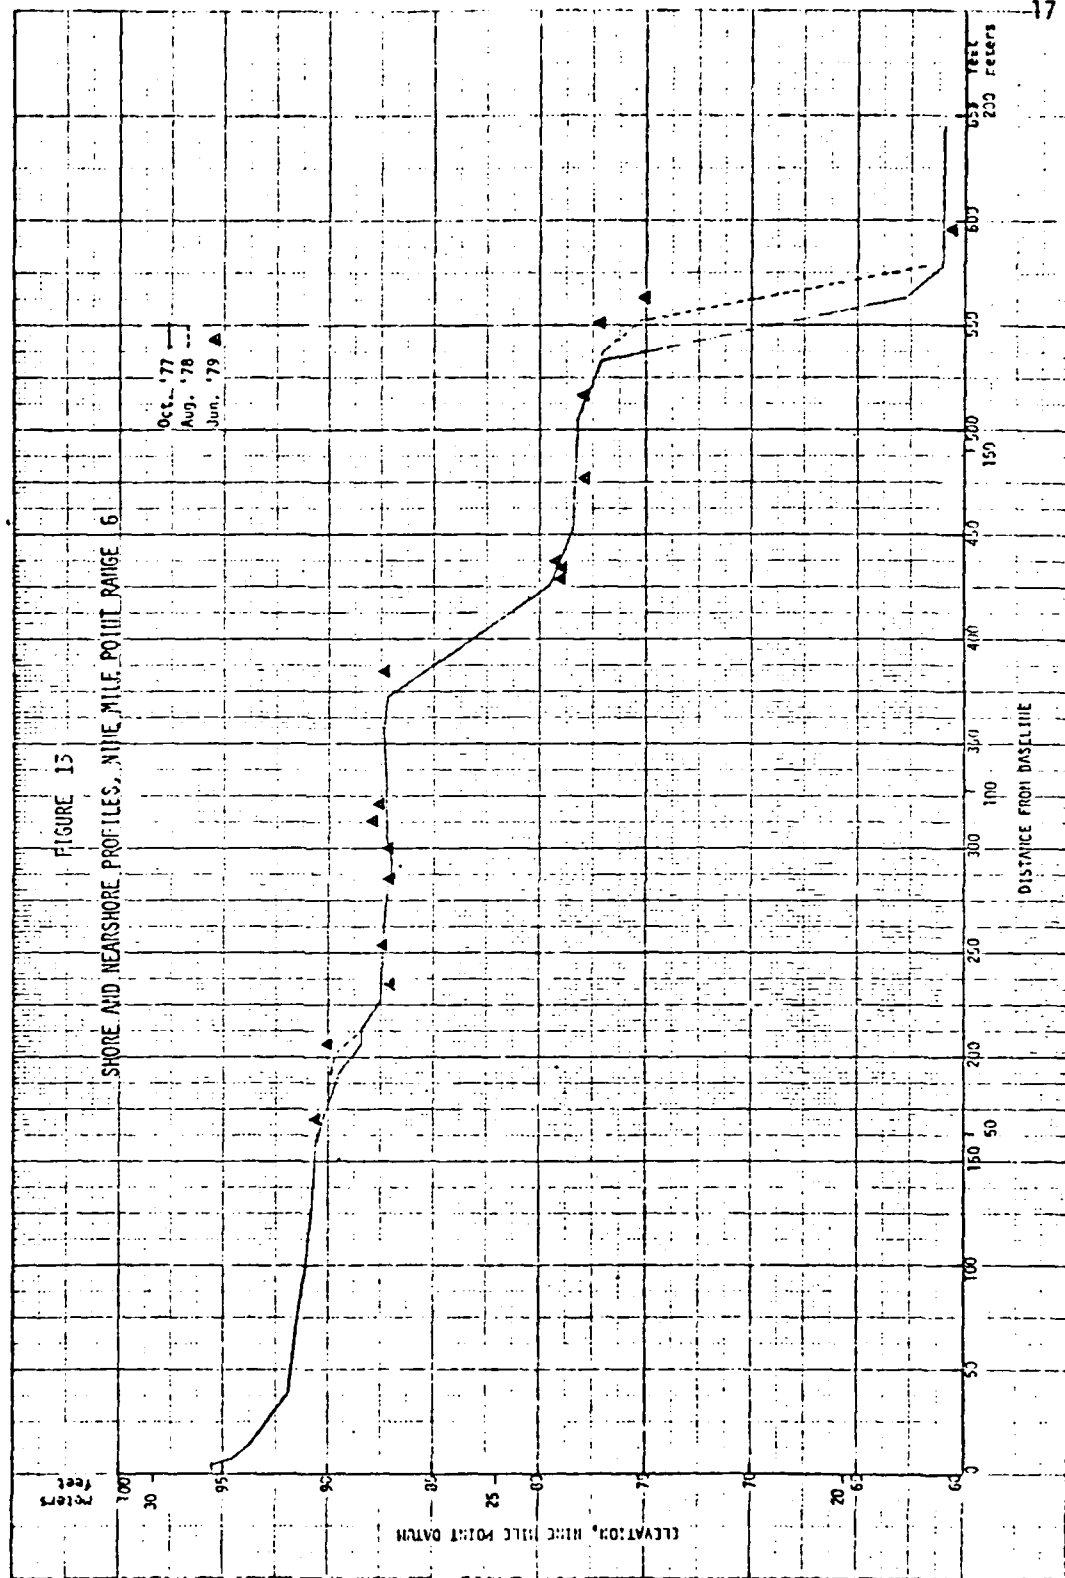
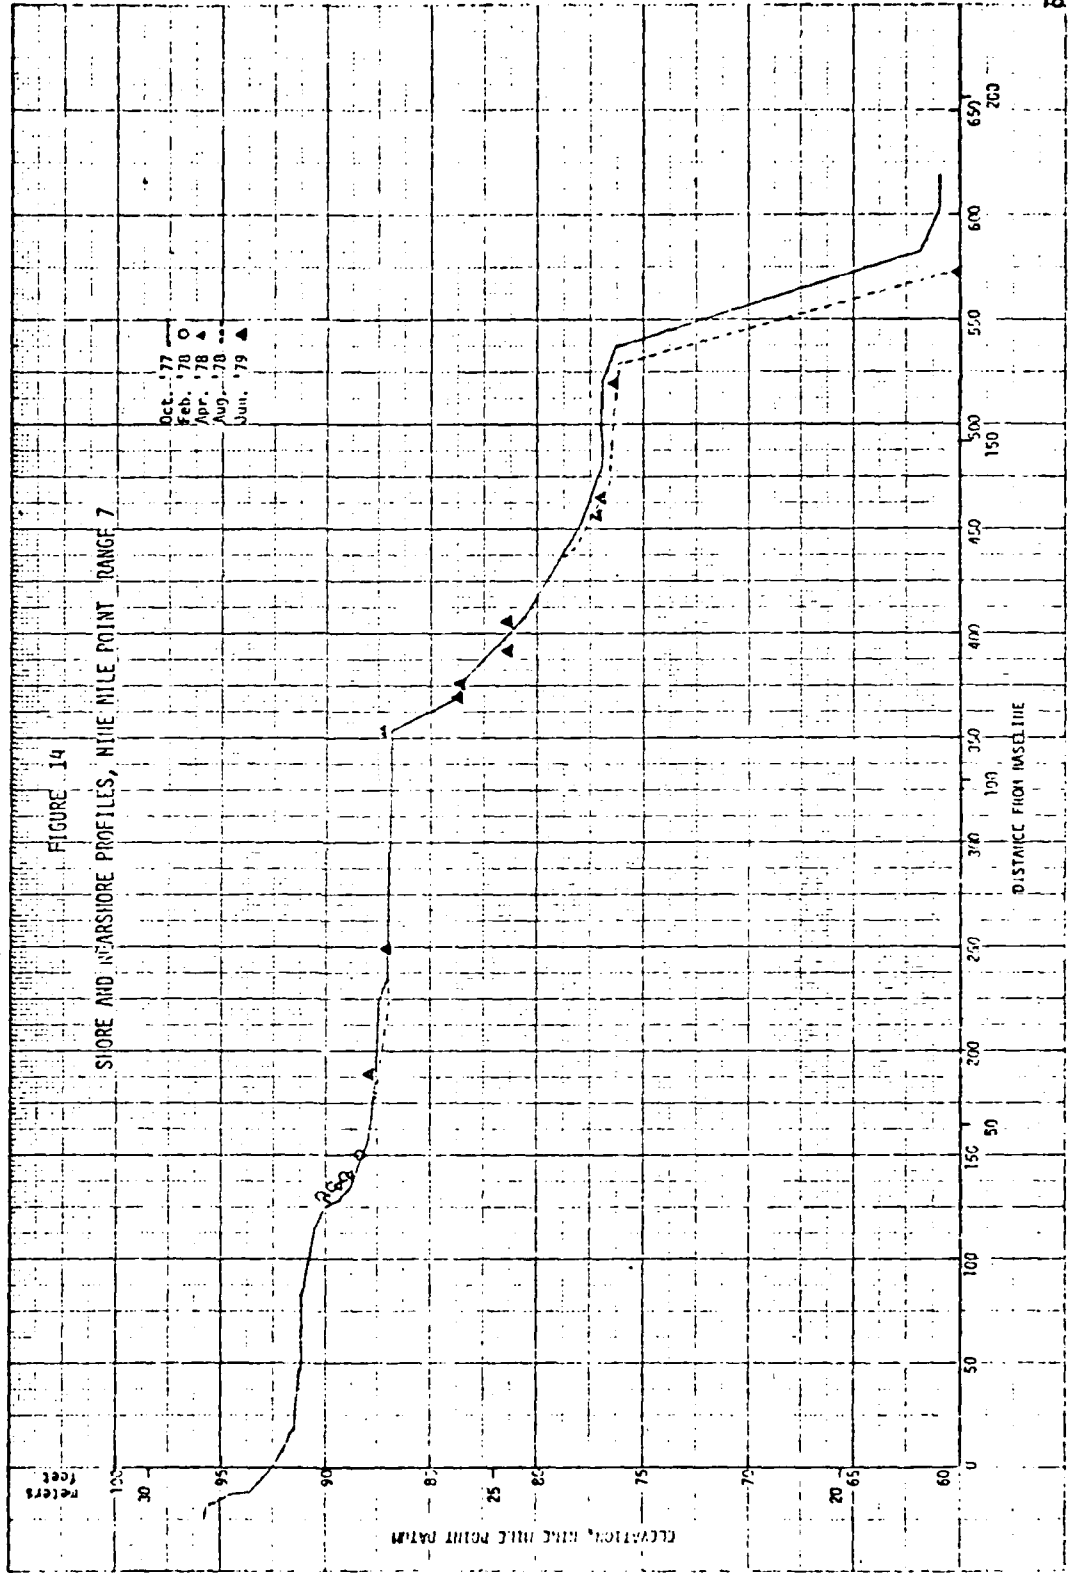
The results of these measurements have been plotted on Figures 8 through 14 along with measurements made in 1977 and 1978. Ranges 1, 2 and 3 on the north end of the study area appear to have filled slightly over the area shoreward of the navigation channel. The offshore depression noted earlier on range 5 at 100 m. from the baseline has remained filled. Ranges 6 and 7 show a further migration of the submerged offshore berm. As noted in the report of 1978 the offshore berm located on these two ranges is actively influenced by vessel drawdown. The apparent bottom movement near the navigation channel again appears to be quite erratic from range to range. The river current changes quite significantly from main river section to the region in shore. Thus the boat used for making the soundings experiences some change in speed as it attempts to move along the range. This greatly influences the measurements of boat location in

the region where river velocity changes rapidly. It is likely then that much of the 'apparent' movement shown near the main river channel relates to the accuracy of measurement.
